# Durability of retro-reflecting materials for road signs

Nordic field test; test signs 1996->

Research reports of the Finnish Transport Agency  
50eng/2016

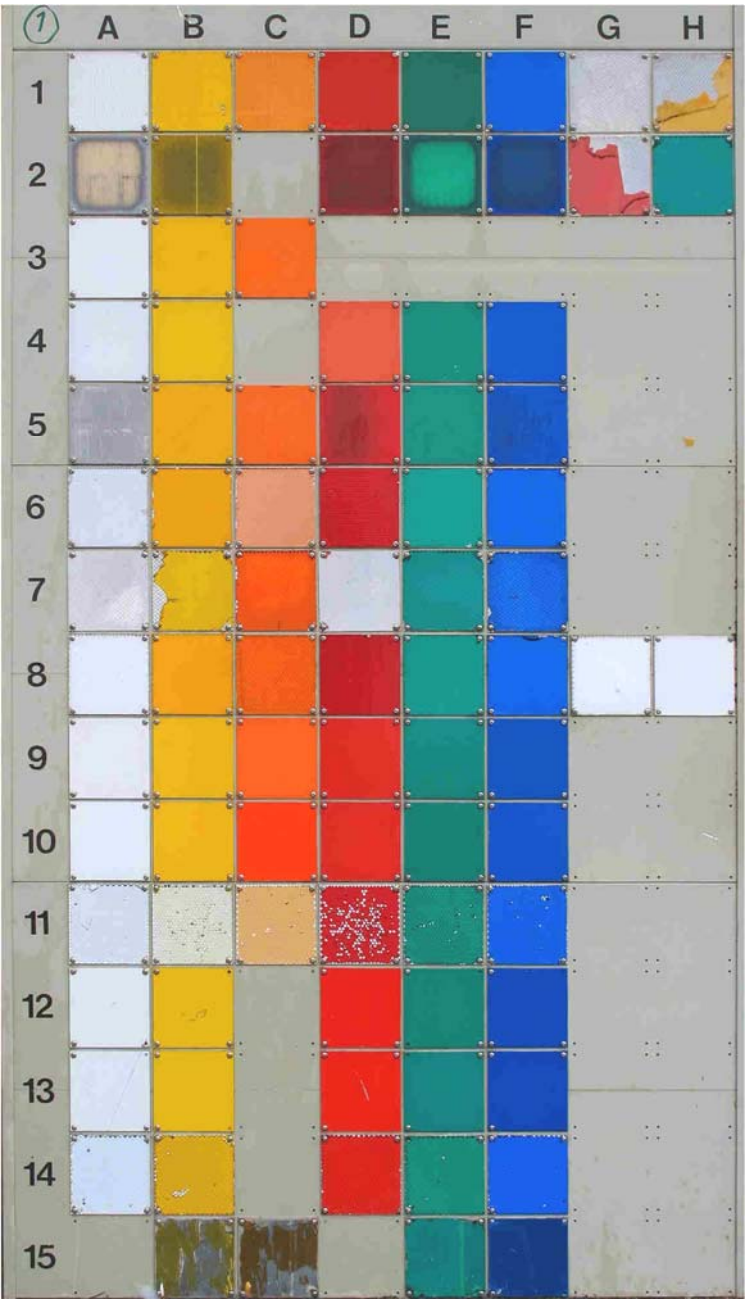
Figure 12. An example of a picture of the trial sign #1, along road #79, aged 19 years (picture June 2016, Timo Unhola).

The dependence of day visibility on night visibility is not very clear (see. Figure 19). This is particularly striking regarding materials in row 1, which reflect well (see. Cover art), but do not during the day seem especially white (see. Figure 12).

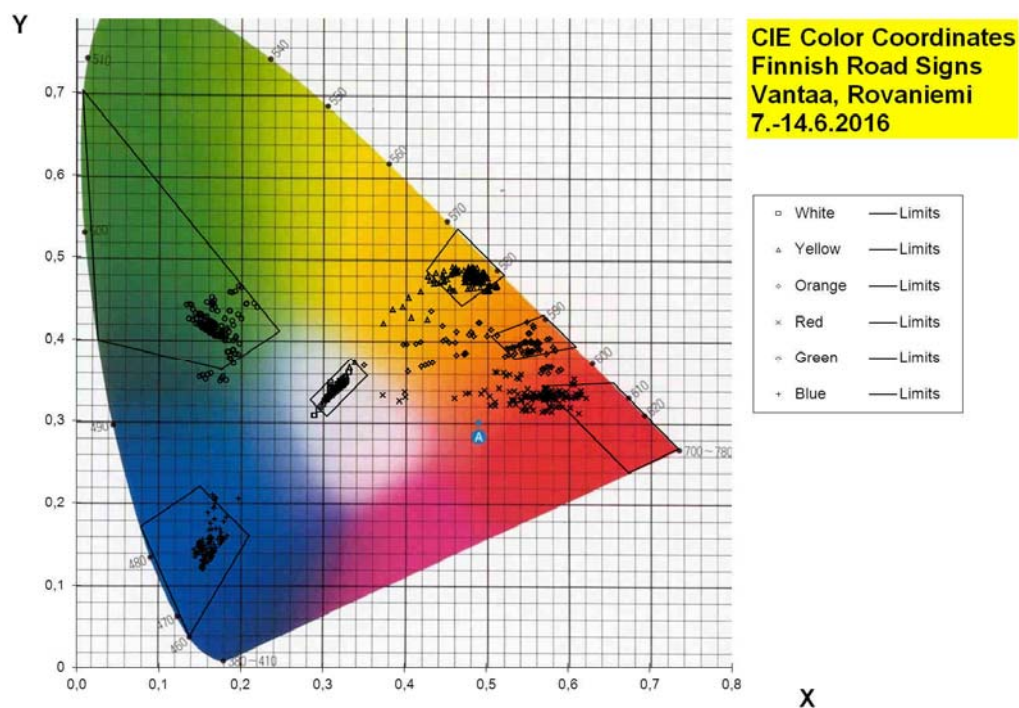
Figure 17. Trial material colors in CIE-coordinates in 2016. Requirement areas are presented as quadrilaterals.

Material colors outside requirement areas in 2016 (figure 17):

White materials have remained in the requirement area, if the film is in place.

The yellow materials have faded or shifted towards white (about one tenth of them).

The orange materials have faded or shifted towards yellow or are already in the beginning of the trial (2004) too red (row 10).

The reds have faded (already in the beginning in the corner of the requirement area) or moved in the direction of orange but only in Rovaniemi. The reason for this single clear difference between the places of trial signs is not evident.

The green materials have moved towards blue (only a dozen or so), or are already in the beginning of the trial (2004) too blue.

The blues have faded (only a few).

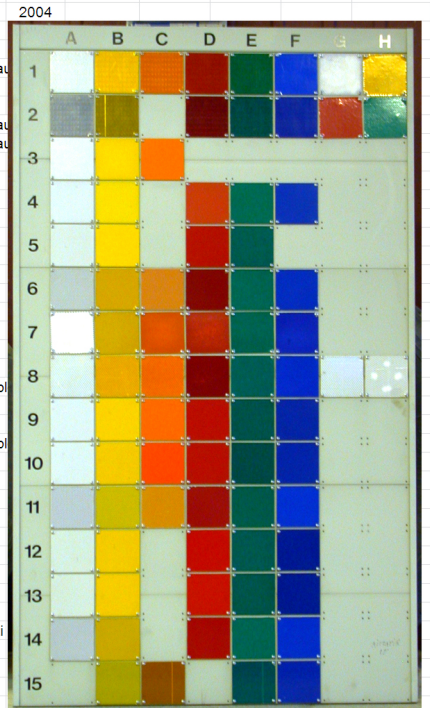
Very strange wear on Sign 5 sheet 8H (four worn patces very regularly spaced, not from measuring)
